AL-IV-A-170

The Rizer Property Survey District
S. Mechanic and Harrison Streets, Cumberland
Allegany County, Maryland
Ca. 1890-1925
Access: Public

Maryland Inventory of Historic Properties Form

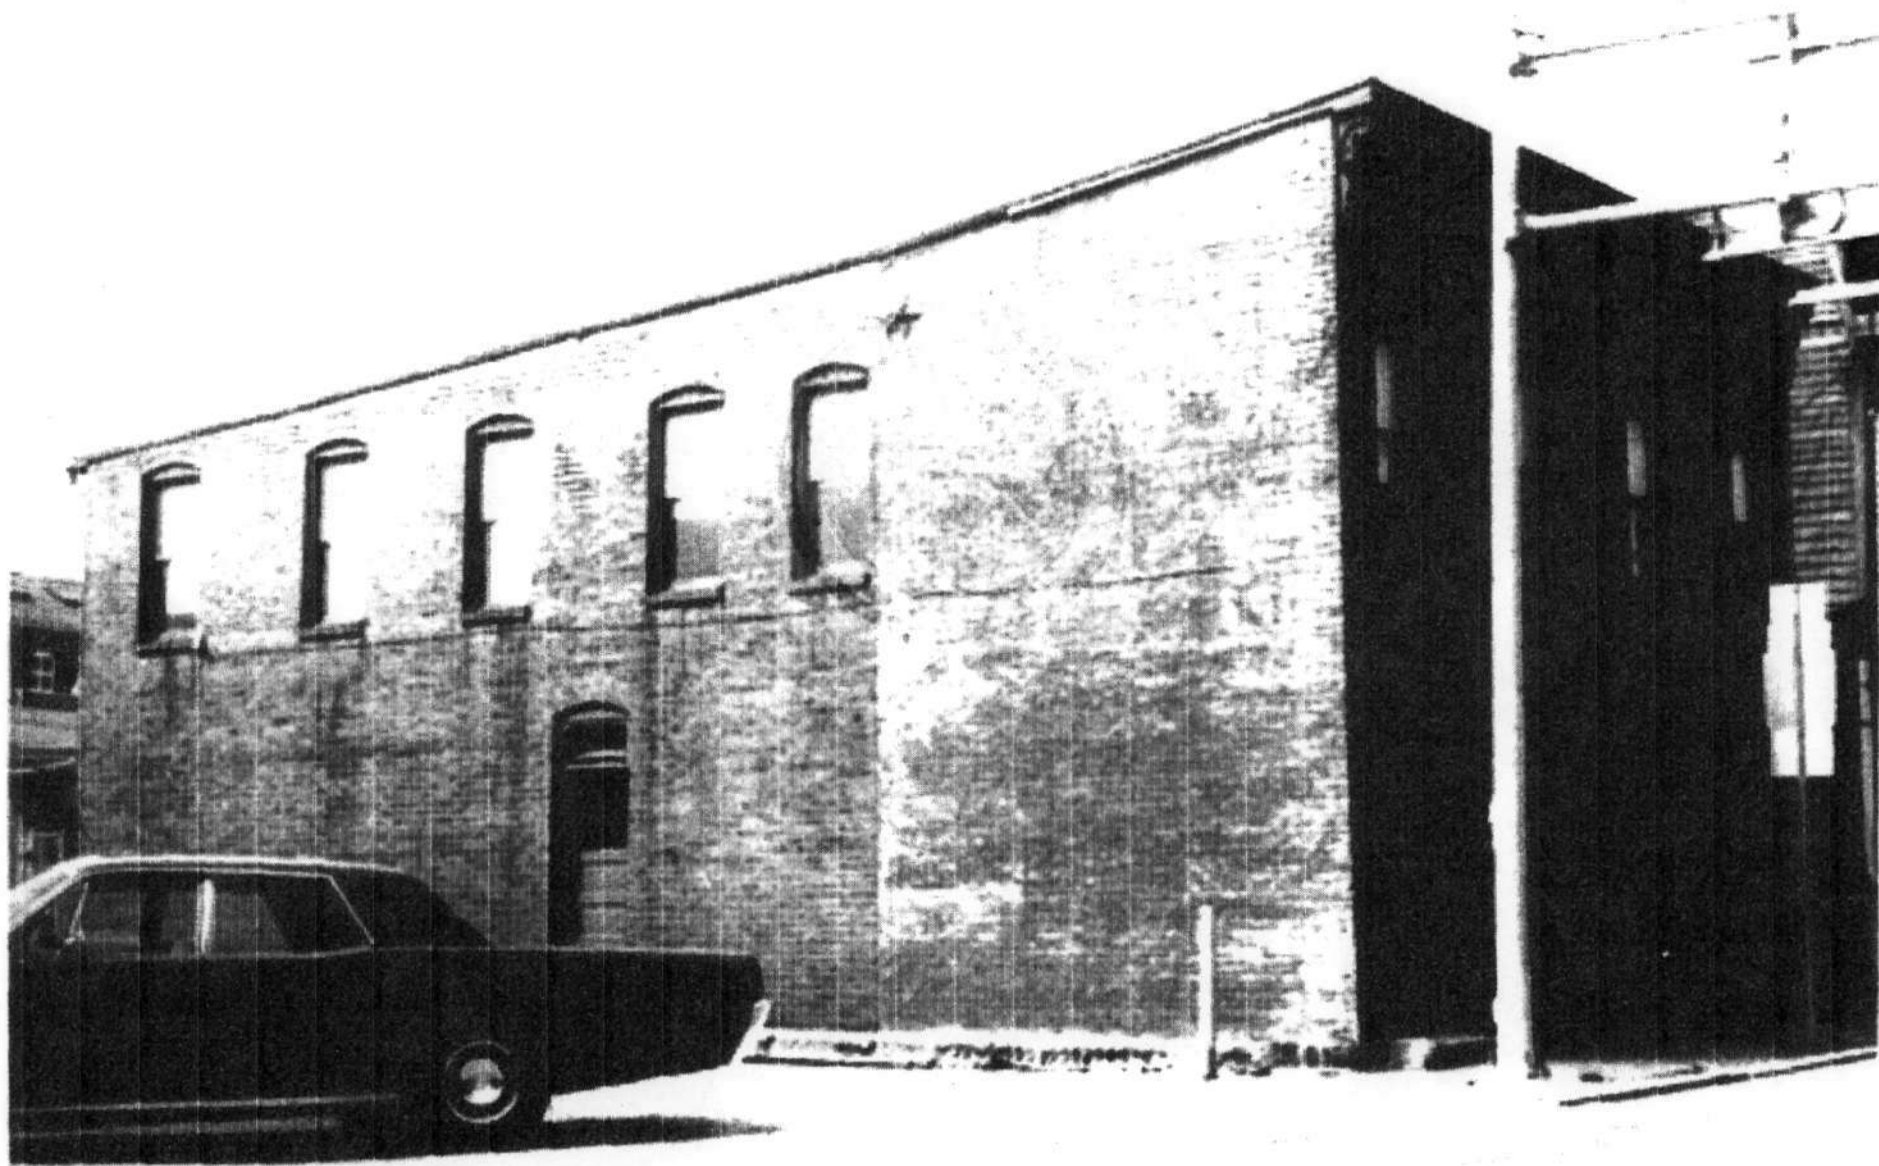
ca. 1960 photo of 19 Harrison St., note #21 is already gone and #13-15 (right) is still standing.

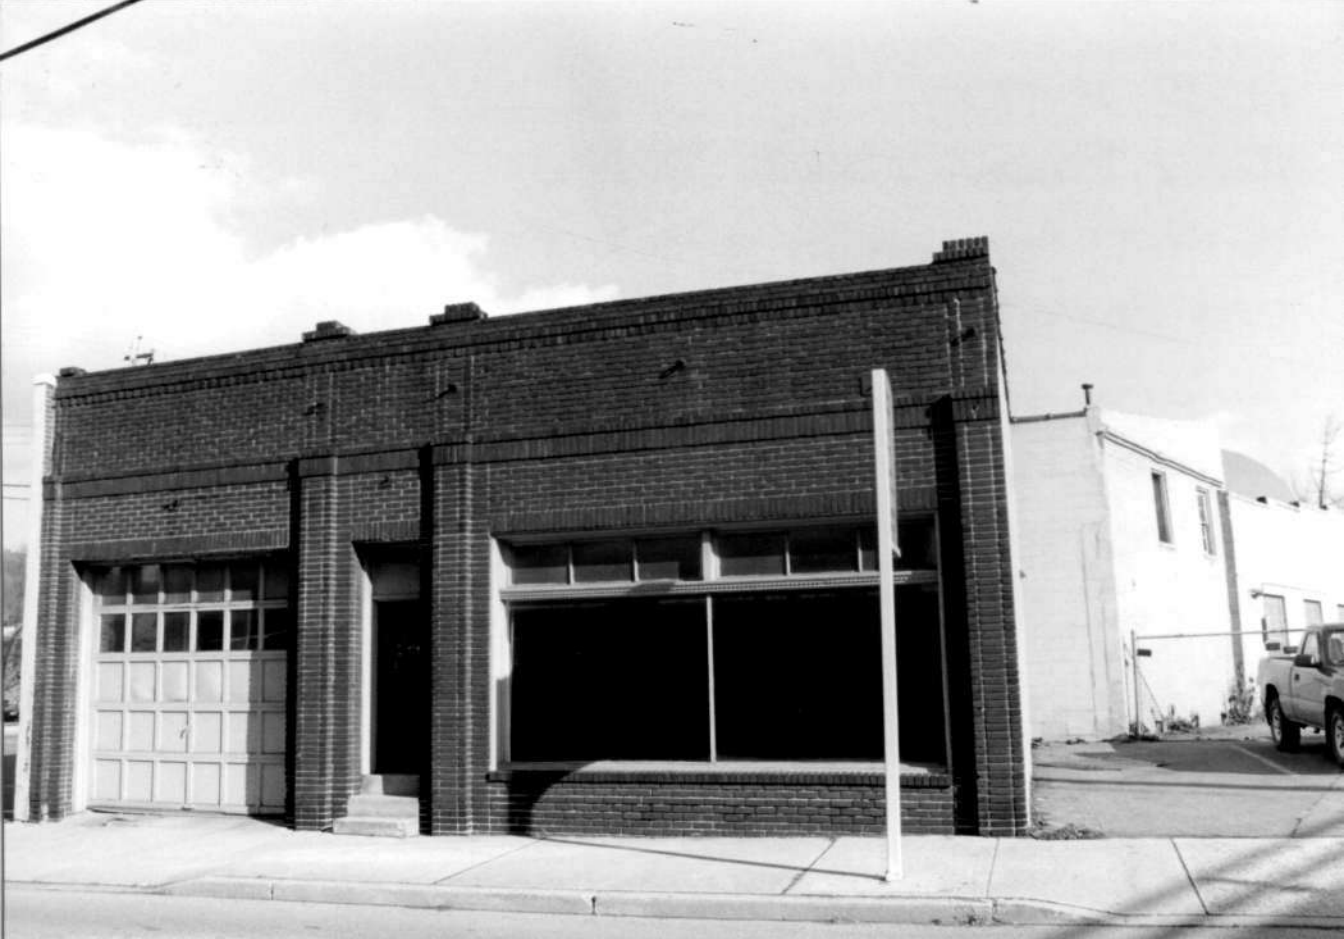
1 of 36

210 S. Mechanic St. NE View

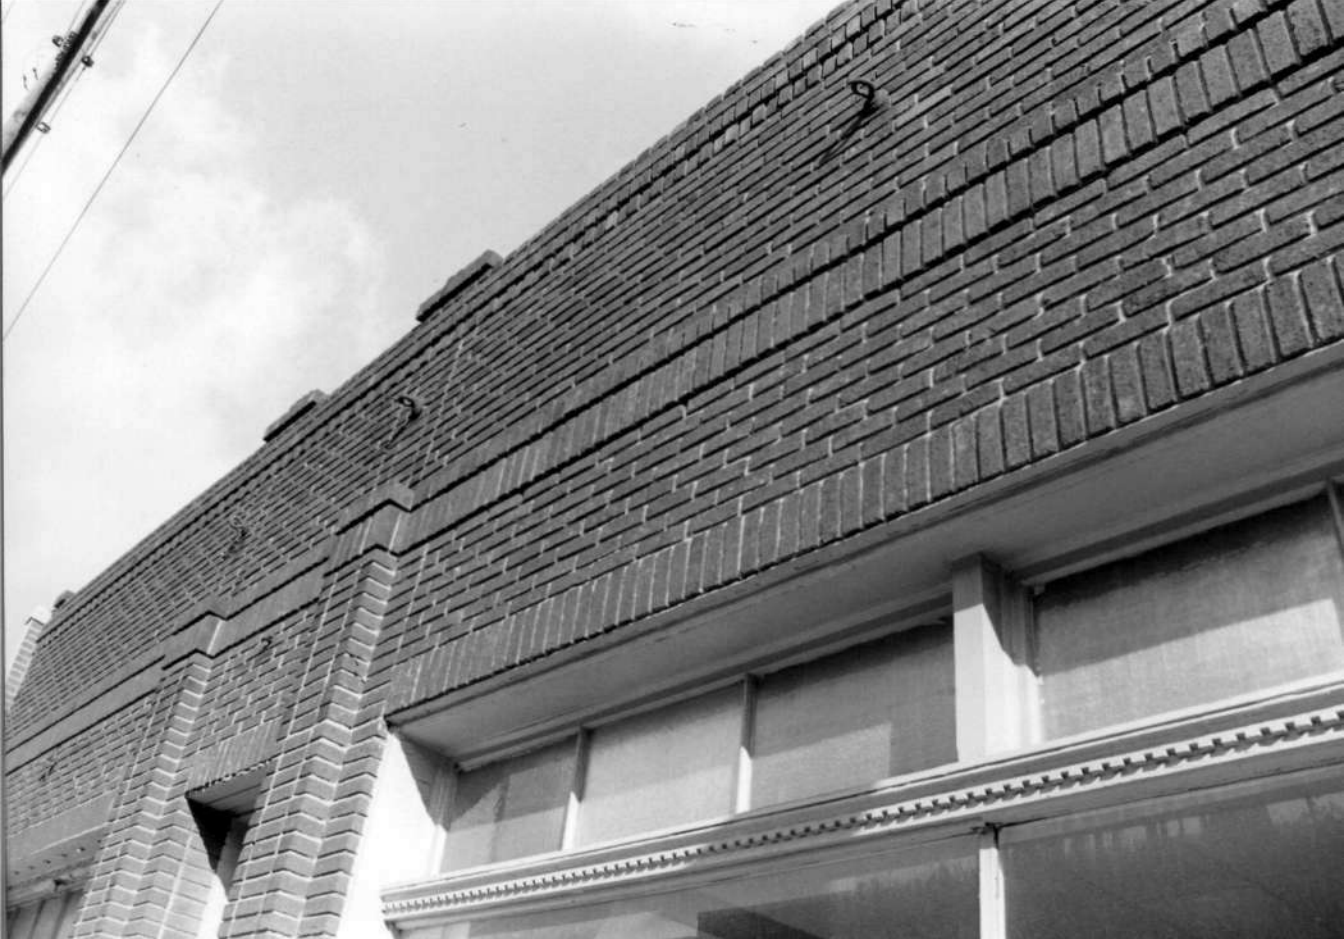
2 of 36

210 S. Mechanic St. Facade detail

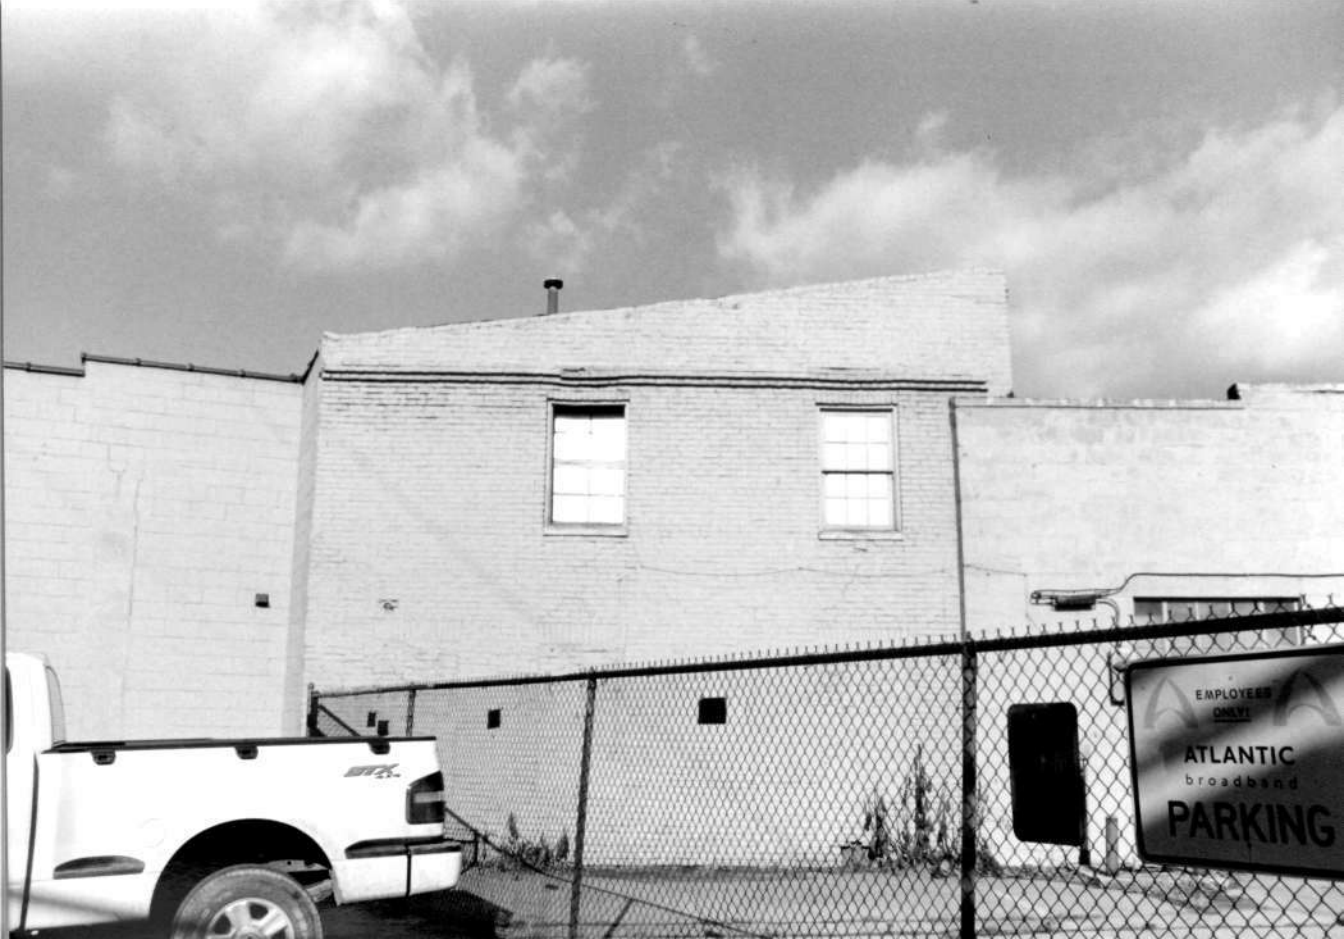
4 of 36

210 S. Mechanic St., S. Elevation, brick section

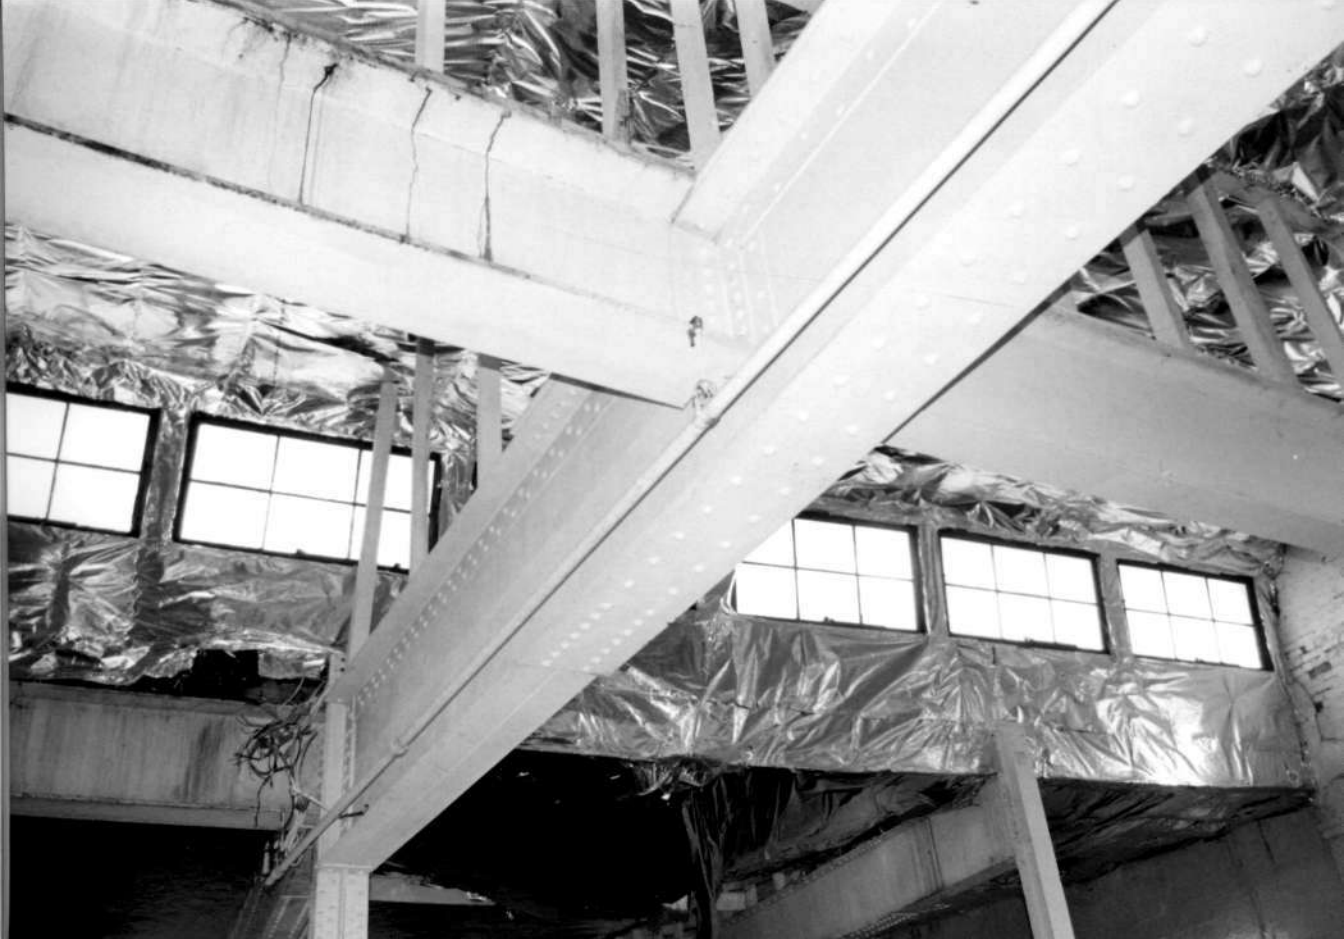
13 08 30

210 S. Mechanic St. Interior, Structural
System detail (brick section, saw-tooth)

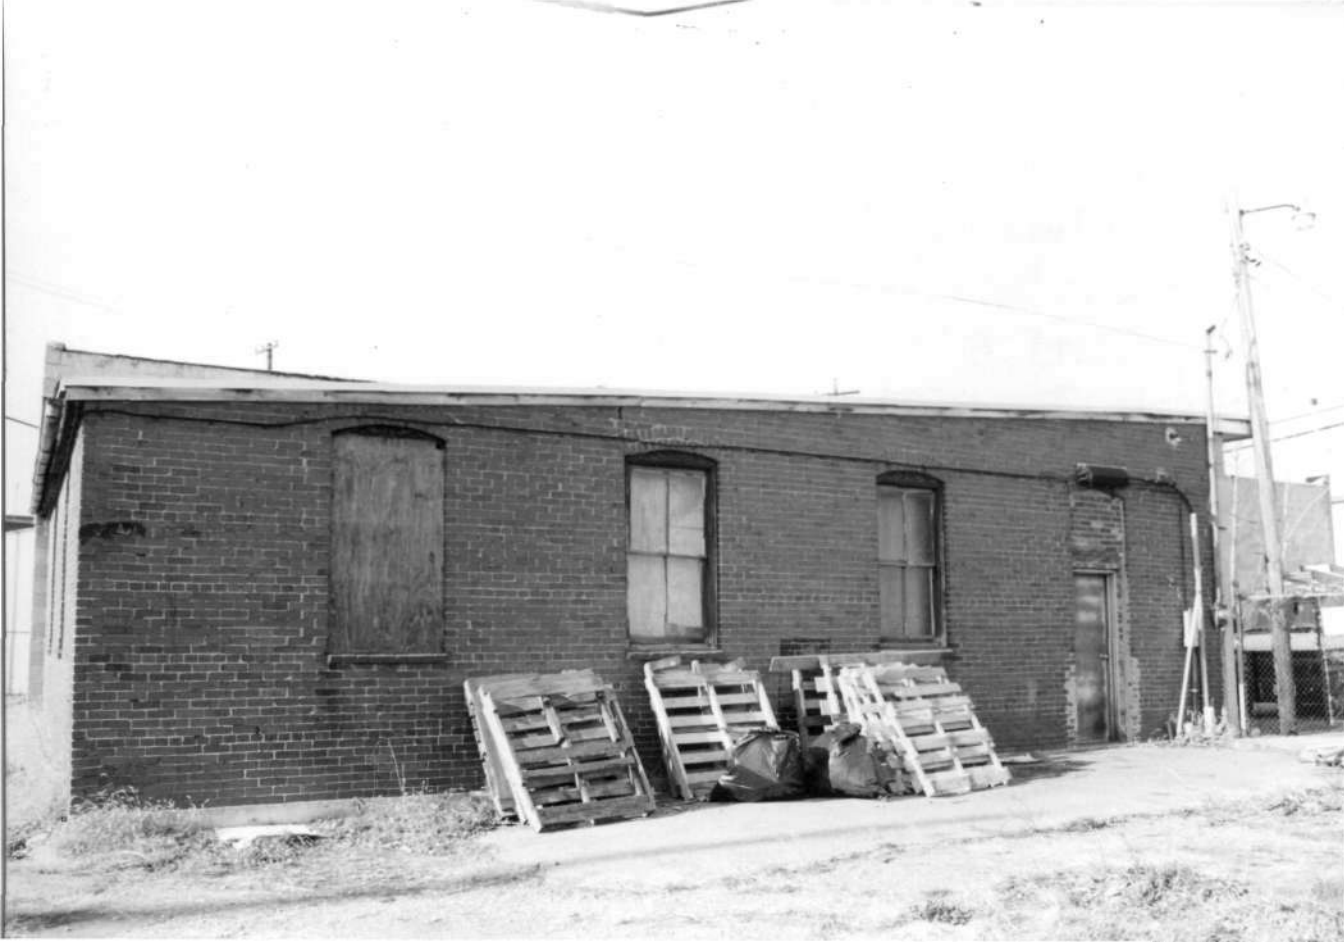
#17 of 36

In the east elevation there are four openings, three windows and a door. The window and door openings are segmentally arched with double row of brick headers defining them. Windows have two over two pane sash within narrow mitered frames with ogee molded profiles. The arched space is filled in with decorative machine-carved wood scrollwork. Windows have two over two pane sash covered at the inside with plywood sheets. The entrance in the north bay had a transom, but it was filled in with brick and the entire door frame replaced with the current one. The entrance bay has the same double brick header arch segment as found on the other openings. At the rear or south elevation there are two windows. These also have two over two pane sash, but because of the slope of the shed roof, they do not have enough space above to accommodate the arched headers. The west elevation was configured similarly to the east elevation, but it now abuts the concrete block building next door. From the inside the former windows and door still show although they have been filled in with brick.

13-15 Harrison St. E. elevation, NW view

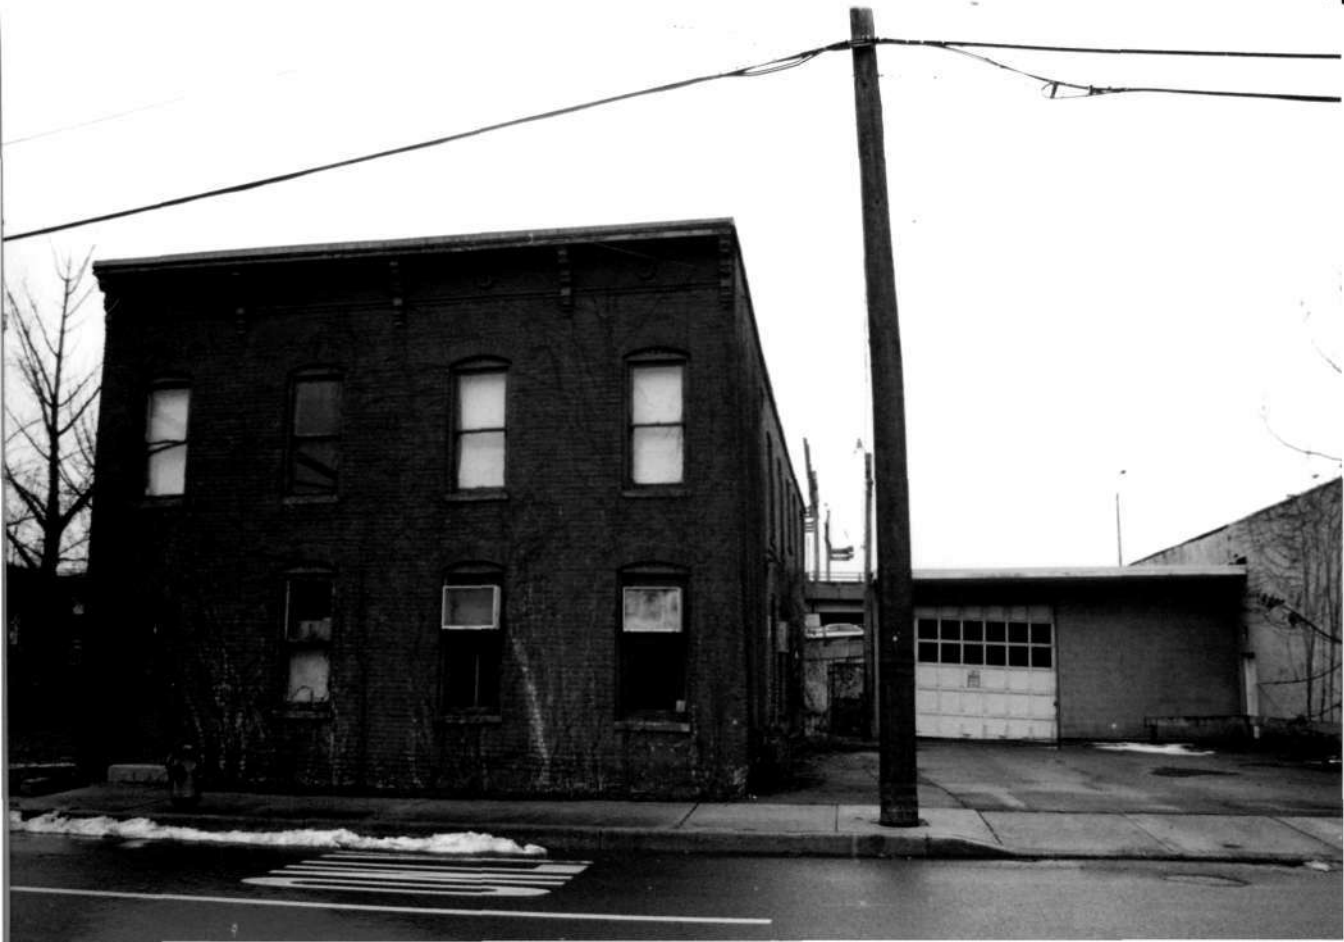
#23 of 36

19 Harrison Street: This brick building is a two story, four bay Italianate style dwelling, extended to the rear with a five bay two story addition. The entire building is covered with a shed roof, now failed. The original building which is quite shallow in depth appears to date from the 1890s and the rear addition from the 1920s. The bricks forming the rear addition are hard-fired with a slight sheen, as opposed to the softer bricks of the front section, which have been painted, probably for much of their history. The front part is constructed in common bonding with bricks laid in a ratio of six stretcher rows to each header row. Foundations are not clearly evident for the front portion of the building. The façade of the building is set directly against the sidewalk, with an empty lot to the east, next to an I-86 on ramp and a parking lot on the lot to the west, with the brick garage at 13-15 at the rear of the adjoining lot. At the back of the lot is a small grassy yard with a large satellite dish overhanging onto the property.

19 Harrison St. S view N elevation

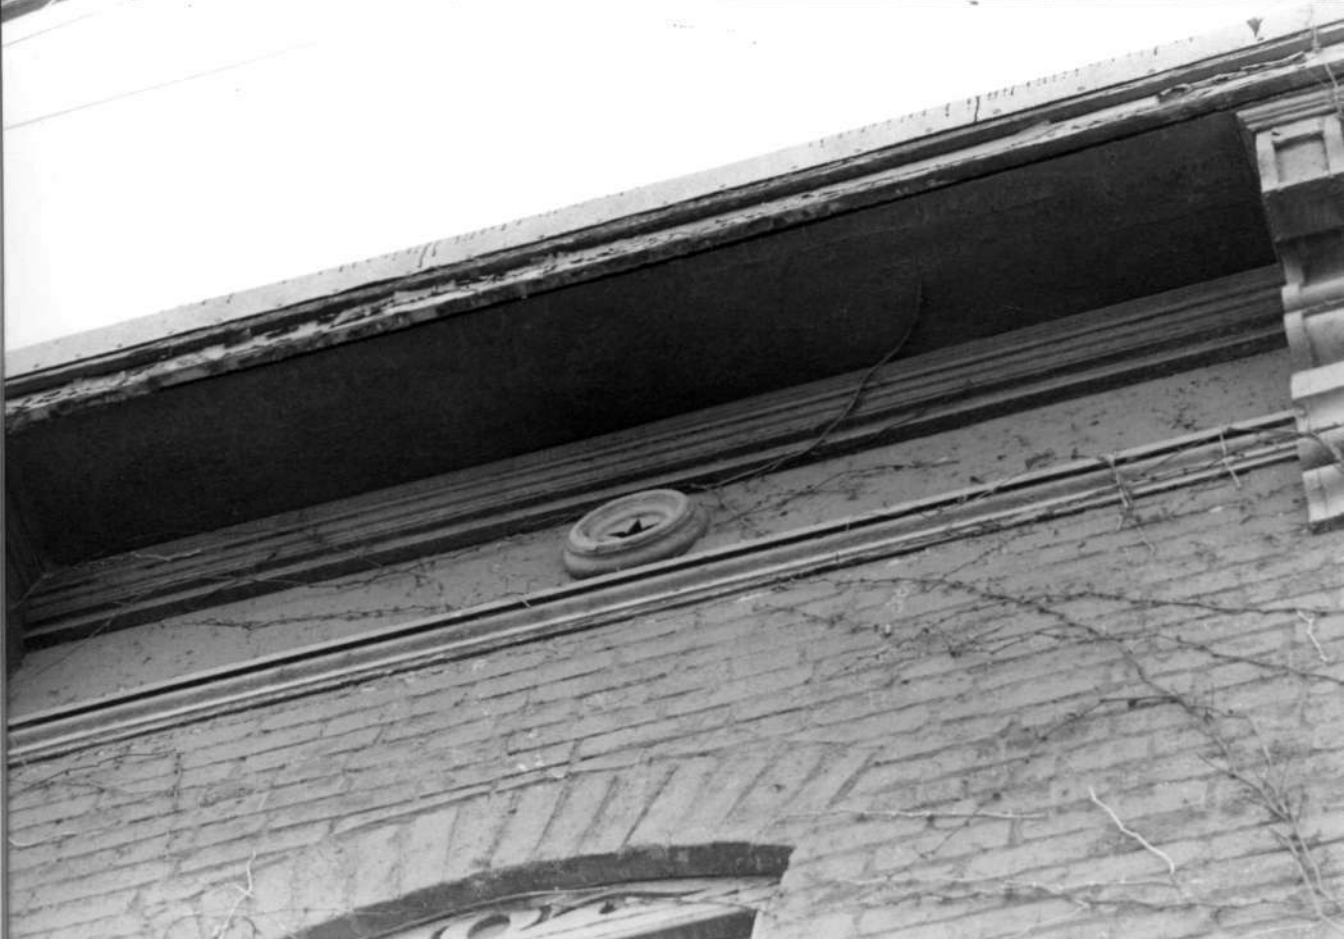
#25 & 36

The most character defining feature of the front of the building is the elaborate bracketed cornice with machine carved decorations. At the bottom of the brackets is a wooden cornice band applied onto the bricks, and between the brackets round turned wooden decorative blocks with five pointed stars cut into their centers. The main entrance is located in the east bay of the front elevation, with three windows to the west. All windows have single pane double-hung sash, most with the glass removed and some boarded on the interior surface with plywood. Windows and doors have arched headers, lined at the front elevation with a single course of upright stretcher bricks. The area within the arched space has decorative machine carved scrollwork. Window frames are narrow and mitered and have an ogee molded surface. The front door is a replacement, metal with a small square window. There are no windows or doors in the narrow side walls of the front section of the building.

19 Harrison St. N. elevation, detail, cornice trim

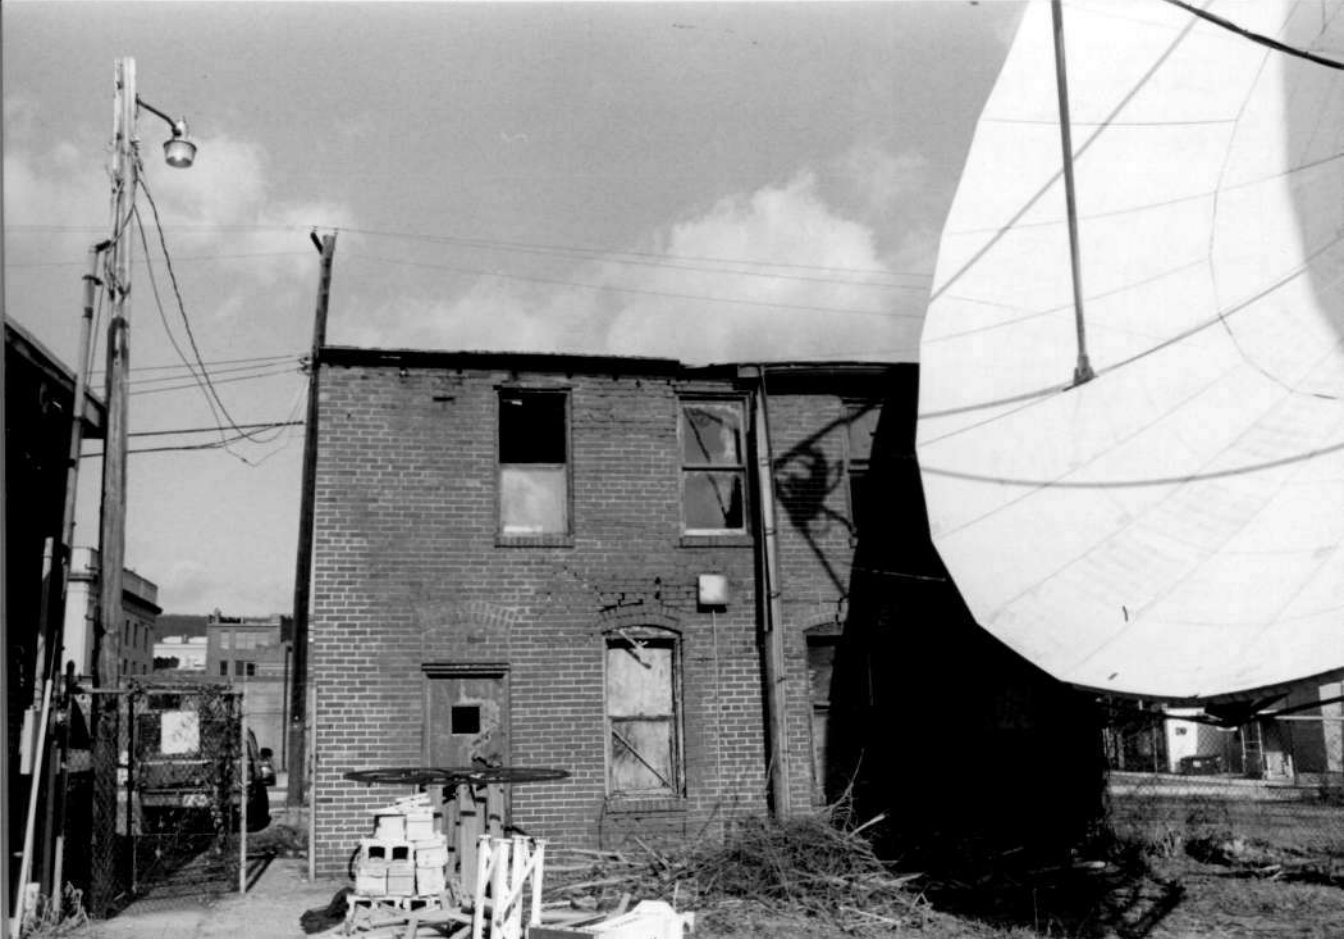
28 of 36

The south elevation has four bays at the first story, arranged door, window, window, door. There are three windows at the second story, not aligned with the first story openings. The openings are trimmed like those elsewhere on the addition, except that the upper story windows do not have segmental arched tops because they are too close to the eaves. Both doors have had their transoms filled in with brick. The west door and framing have been replaced.

19 Harrison St. S. Elevation, N. View

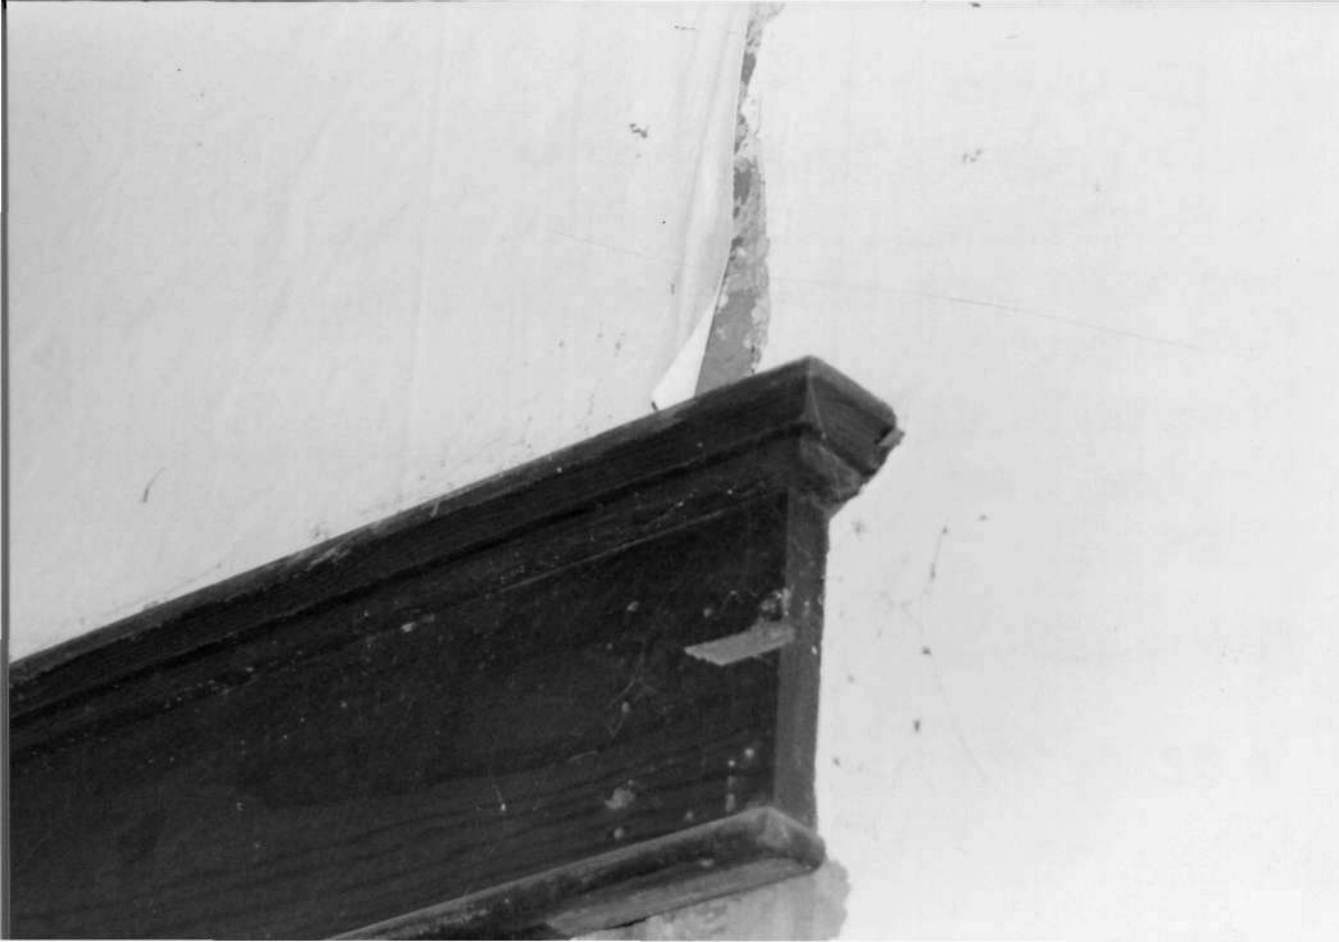
32 of 30

Most of the interior of the house is not accessible because of severe deterioration and structural instability. The front entrance opens into a stair hall with the staircase rising to the second floor along the east exterior wall. To the west of the staircase is a narrow passageway with two doors opening into a large room which includes the front section of the building and the two north bays of the addition. Interior woodwork in the stair hall appears to date from the 1920s and consists of flat architrave trim with a top piece with a projecting bead at the bottom edge and at the top with an ogee cornice. This trim is used consistently throughout the portions of the interior available to view. The staircase, likewise appears to date from the 1920s. It has a square molded newel post, rectangular balusters, and rail with a grip-top. Balusters are rectangular and are set into a closed stringer band with a projecting bead at the top and bottom edges. The woodwork design is influenced by the Mission Style.

19 Harrison St. Interior, typical trim detail

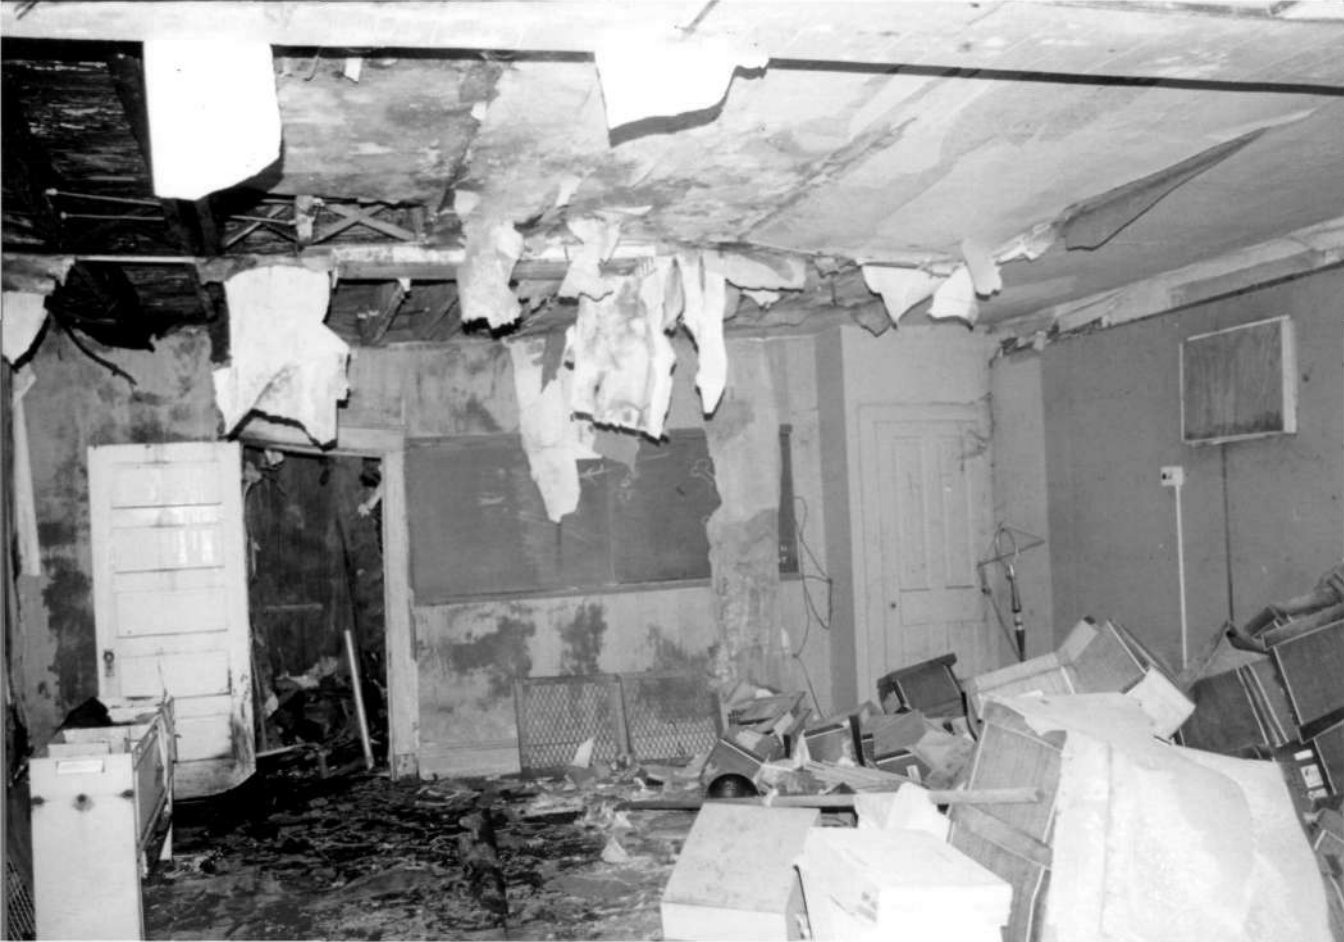
#33 of 36

The room to the west of the stair hall sustained such damage from roofing failure that neither it, nor the rooms behind could not be examined thoroughly. In the south wall, a five panel door opens into the room behind. There is also an apparent closet in the southwest corner of the room with a four panel door.

19 Harrison St. Interior, West Room, S. view
first floor
